BETTER BUILDINGS

OTTAWA, ONTARIO

CASE STUDY NUMBER 11

REPAIR OF DETERIORATED BALCONY SLABS

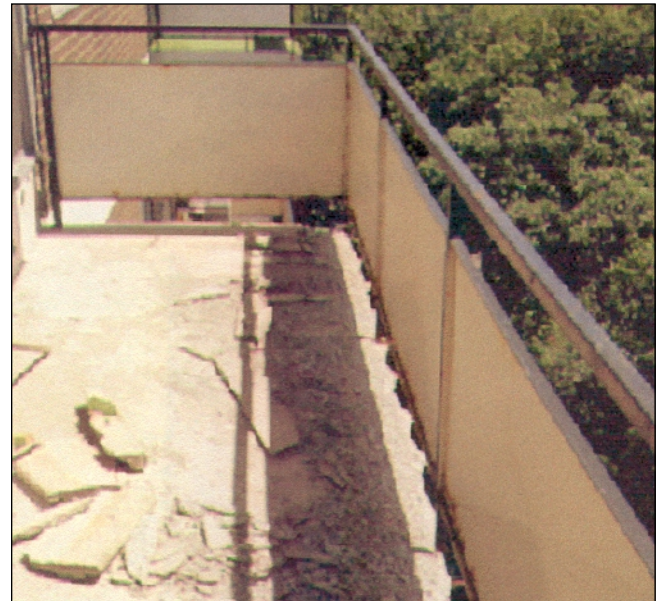
The condition survey showed extensive deterioration of the balcony slabs and balcony railings, with the most severe concrete delamination and spalling at the balcony edges. The concrete deterioration was the result of long-term freeze-thaw action caused by moisture penetration into the slab and corrosion of the balcony slab reinforcement. Inadequate concrete cover accelerated the moisture penetration and corrosion.

Example of extensive spalling

The contractor removed deteriorated concrete and replaced it with Portland cement concrete for through-slab repairs, and polymer-modified concrete and repair mortars for patching repairs.

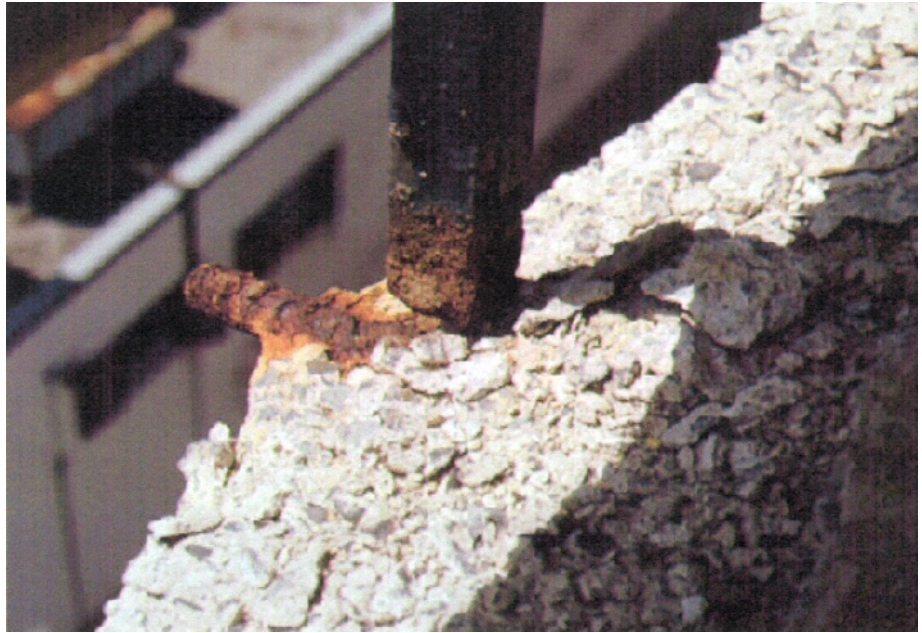
On some balconies, crumbling concrete forced the owner to remove concrete fragments and shore the edges of the slab. Exposed reinforcing steel was visible on 12 of the 56 balconies, typically at the front edge of the slab. The metal railings showed significant corrosion, particularly at the railing panels and handrails and at the base plates of the railing posts. The survey found several loose railing anchors. The original balcony railings also failed to meet current (in 1990) Ontario Building Code requirements.

Railing post/slab anchor - note baseplate has completely deteriorated

All balcony railings were removed and replaced with custom fabricated, galvanized steel railings. Before installation, a paint shop coated them with polyurethane enamel. The new railings meet current (1990) Ontario Building Code standards.

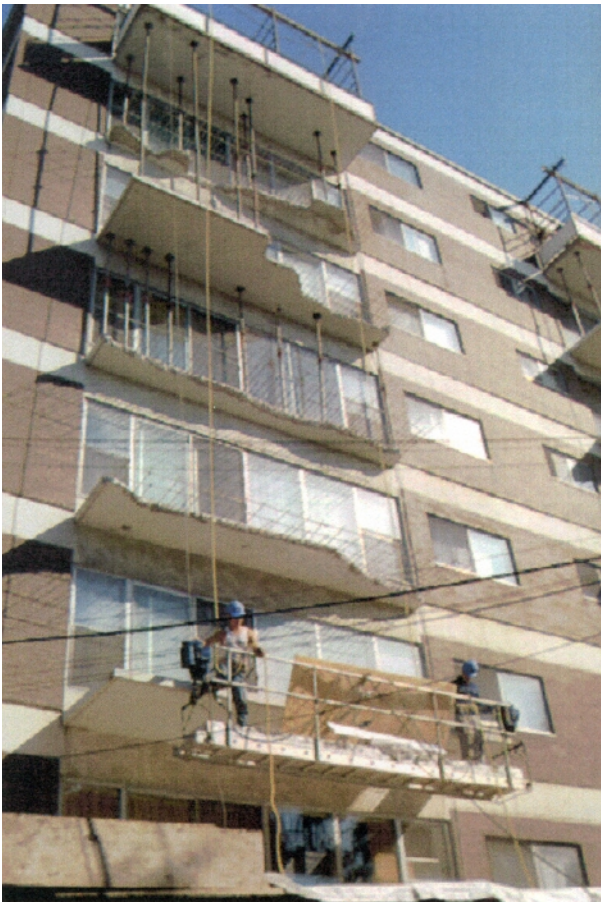
Deteriorated concrete removal in progress

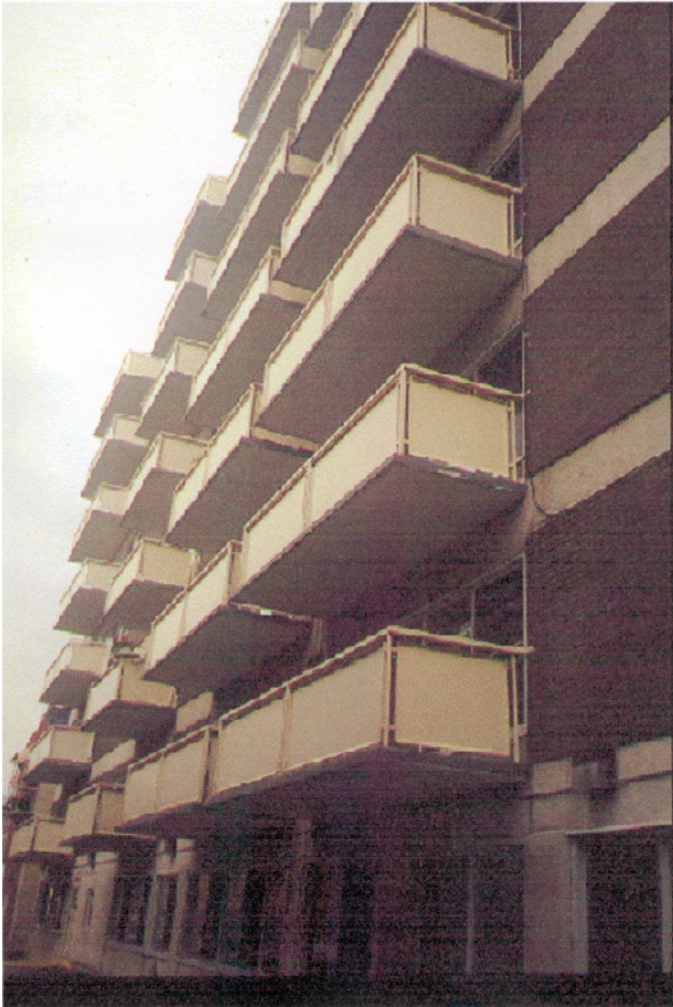
Repaired balcony slabs and railings

Everyone involved, including the tenants, considered the project a success. The project restored the structural integrity of the balconies. It extended the service life of the balcony slabs and replaced deteriorated balcony railings with new guards meeting current standards. The work was completed on budget and in a reasonable time. Residents were again able to safely enjoy their balconies. The work improved the building's appearance and curb appeal. A good part of the success was the project's
