# BETTER BUILDINGS

## CASE STUDY NUMBER 45

### REDUCING MAINTENANCE, OPERATING AND ELECTRICAL COSTS IN A HIGH RISE CONDOMINIUM

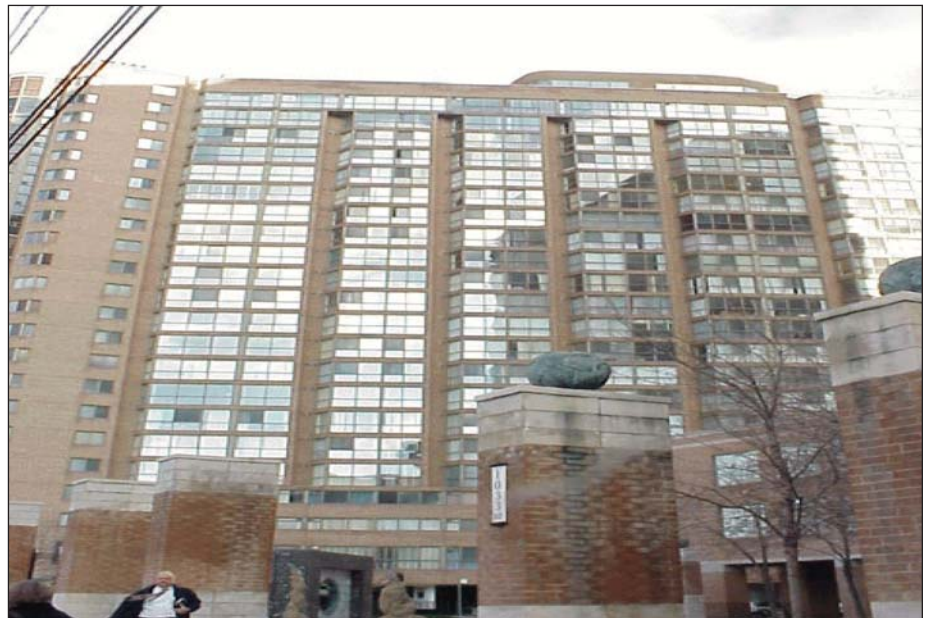
Figure 1.

The building, constructed around 1986, has a floor area of 25,284 m<sup>2</sup> (272,000 sq.ft.) and contains 336 suites. There are also three levels of parking below grade.

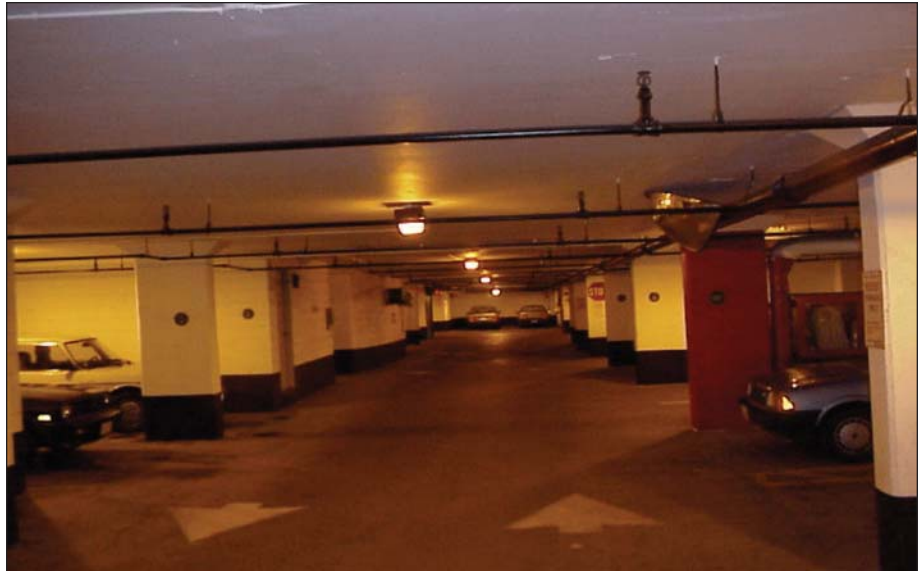
Figure 2. New garage lighting

1. Garage Lighting Retrofit: The original fluorescent lighting in the garage was removed and replaced with high pressure sodium lighting (100 fixtures of 150W and 7 fixtures of 100W units).
2. Building Automation System: A new Landis and Gyr System 600 was installed. This system provides direct digital control of most loads over 2 horse power; equipment rotation; time of day control; proportional, integral, and derivative (PID) loop (valve) control; demand limit and chiller water reset; fresh air supply free heating/free cooling; and temperature set-back on domestic hot water; one year of remote monitoring was included in the cost of \$62,000 for this measure.

High pressure sodium lighting results in sharper shading as compared to the original fluorescent lights. Residents reported some discomfort with the new system, but became accustomed to the change.

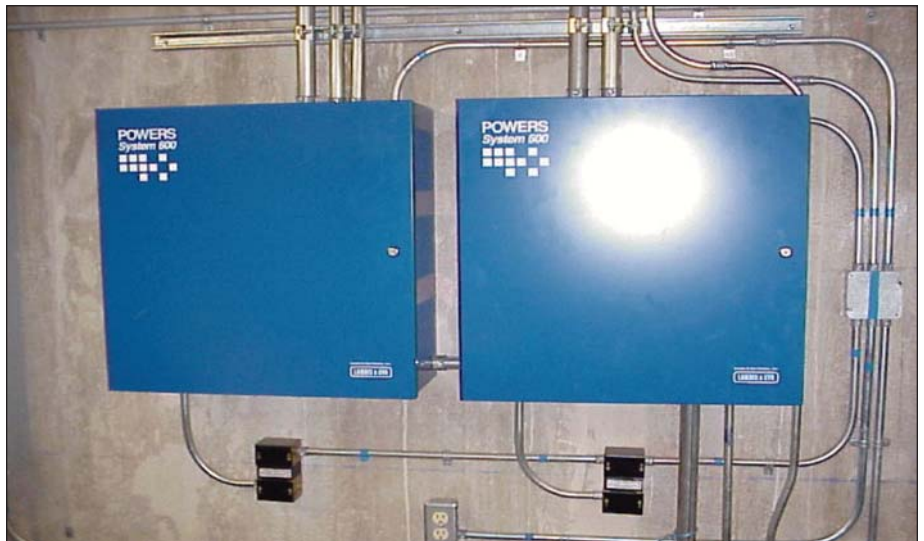
Figure 3. New building automation system

Central Building Automation System (BAS) panels were located in the mechanical penthouse, with contacts and controls as far away as the ground floor. As a result, the routing of control wiring through the existing building was challenging.

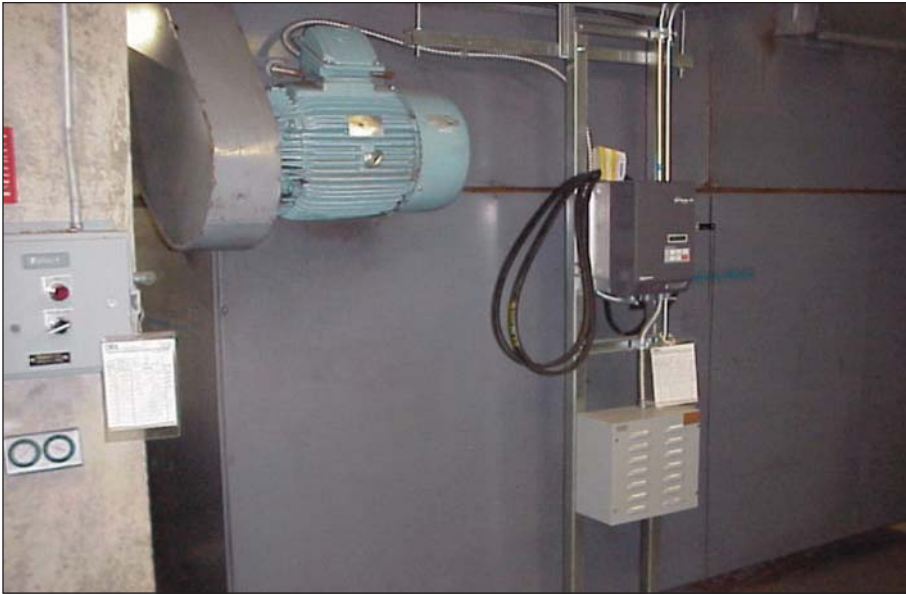
Figure 4. New fresh air supply fans

3. Fresh Air Supply Fans: The original fan motors were replaced with Teco Westinghouse Optim HE motors, with added variable speed control.
4. Hot Tub Conversion: A Phalen gas-fired water heater was installed at the hot tub to replace the existing electric water heater. The original in-line immersion electric heaters were left in place as a back-up to the new system.

The fresh air supply system was re-balanced floor-by-floor following the retrofits.

After one owner, who lived directly above a mechanical room housing one of the new direct drive fan motors, complained about the noise, an acoustic engineer evaluated the problem. Isolation hangers were installed at fans, and non-rigid couplings installed in piping. This reduced the noise enough to satisfy the complainant.
