BETTER BUILDINGS

OTTAWA, ONTARIO

CASE STUDY NUMBER 11

REPAIR OF DETERIORATED BALCONY SLABS

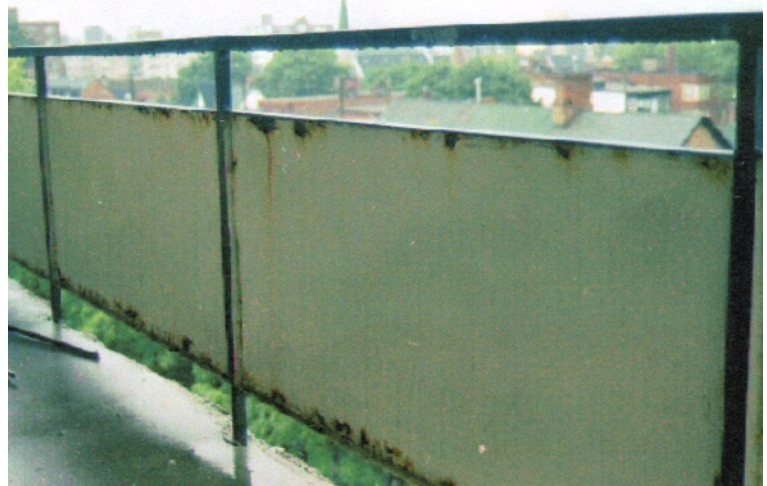
Repaired balcony slabs and railings

All balcony railings were removed and replaced with custom fabricated, galvanized steel railings. Before installation, a paint shop coated them with polyurethane enamel. The new railings meet current (1990) Ontario Building Code standards.
